Table of Contents

Abstract

The Red Lake Watershed District and its project partners have been studying the water quality characteristics of tile drainage within the Red River Basin. The theories about tile drainage being tested are that it should have:

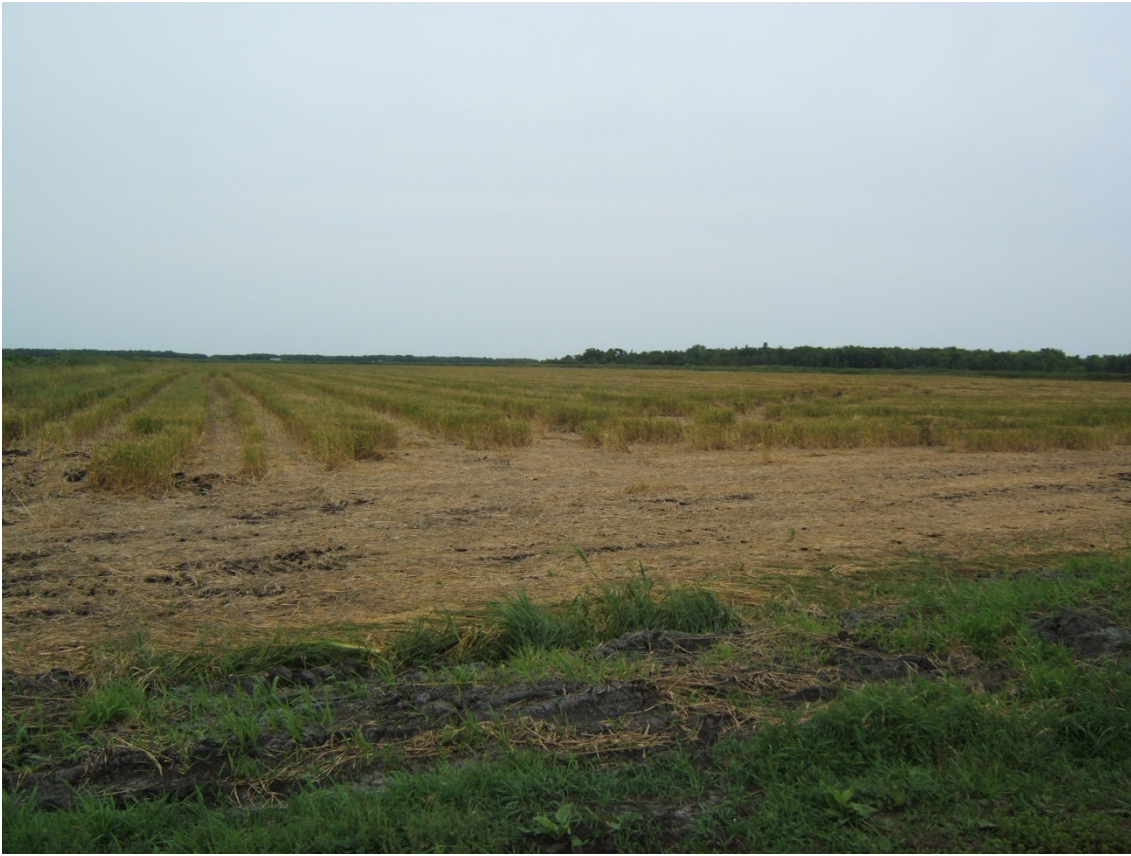
Figure 1. Recently harvested main-line tile drained wild rice paddy

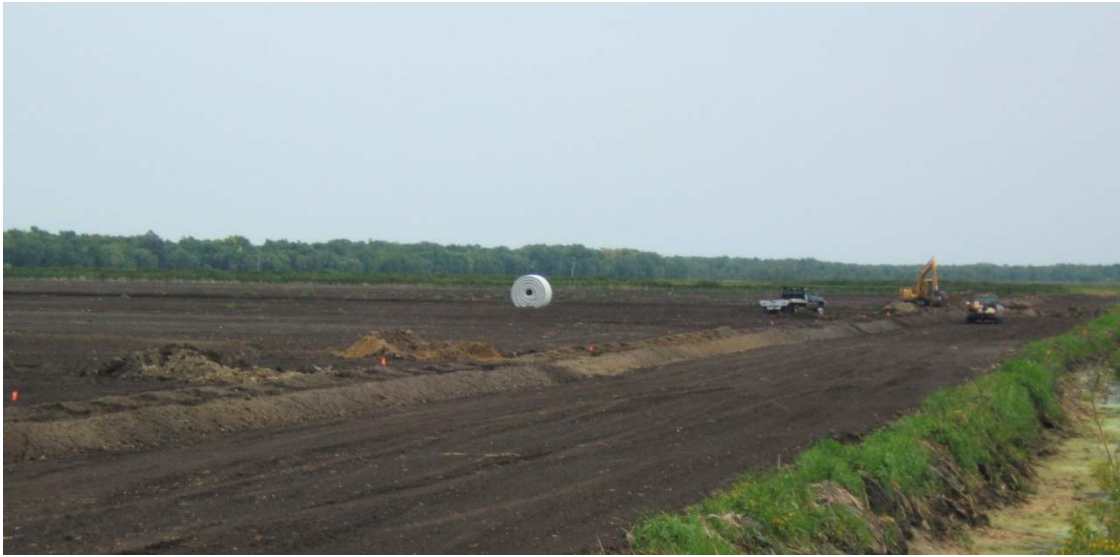
Figure 2. Installation of wild rice paddy tile drainage

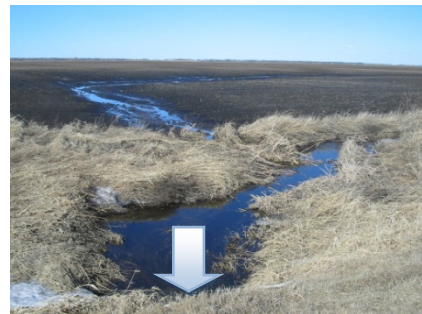
This site was monitored and sampled at the beginning of the project before it was possible to sample surface and tile drainage separately from this field. Samples and field measurements were taken from the upstream end of the culvert. The water at this site originated from both surface and tile drainage.

Samples are no longer collected here, but instead are collected separately at the Bachand Surface and Bachand Tile monitoring sites. This site and the Bachand Tile and Bachand Surface sites are located along Hwy 92, east of Brooks, Minnesota. This field is located in Section 8 of Lambert Township in Red Lake County. Water quality samples were collected where flow from the Bachand field crosses Highway 92 on the south side of Section 8.

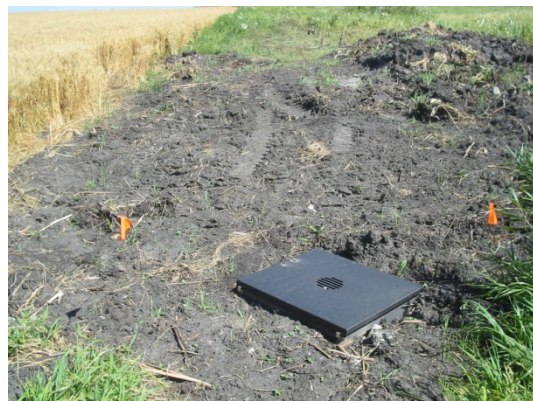
This is the water control structure that was installed on the end of a main line tile line. Field Drainage, Inc. of Brooks, Minnesota installed the structure. Water comes into the structure through the tile line, flows over a v-notch weir, and then exits the structure through a short length of pipe. A HOBO Water Level Data Logger is placed on the bottom of the field (upstream) side of the water control structure to collect a continuous record (1 measurement every 15 minutes) of water levels within the water control structure. This water level data can be translated into flow using a table and/or equation for calculating flow over v-notch weirs. A rating curve has been developed for the weir within this structure.

The tile drainage at this site was installed in 1995. The tiles were placed at about 40 inches deep with 120 foot spacing. The longest run of tile line in the field is $\frac{3}{4}$ mile. The diameter of the outlet pipe is 8 inches.

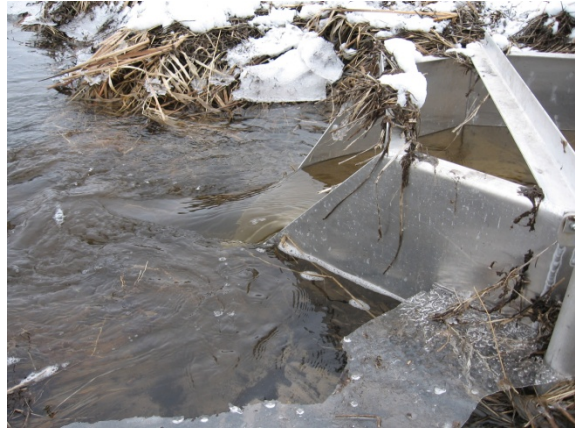
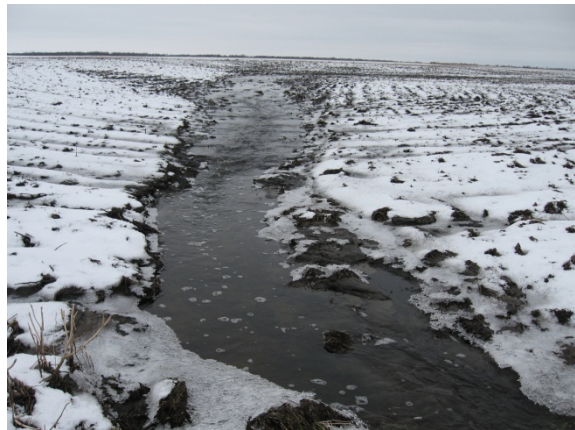
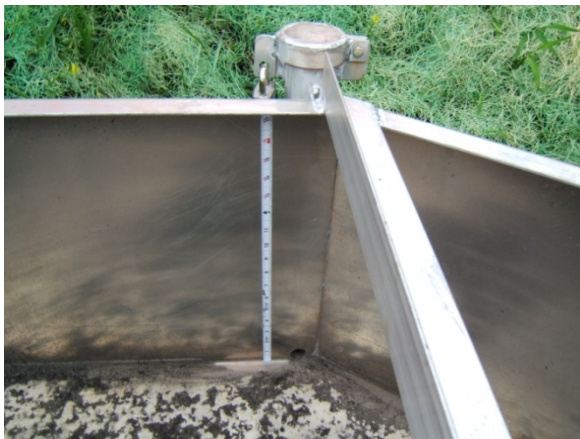
This monitoring site is used to monitor the surface drainage from the Bachand field. An h-flume installed to catch and measure any surface runoff that comes from the Bachand field. Dip samples can be taken from the end of the structure. There is a HOBO Water Level Data Logger installed within the stilling well on the side of the structure to collect a continuous record (1 measurement every 15 minutes) of water levels within the flume. Level logger readings are correlated with manual measurements of water depth at the end of the flume. The water level data can be translated into flow using a table and/or equation for calculating flow through an h-flume.

The stilling well has a locking cap that is secured with a RLWD padlock. Some landscaping has been done to ensure that water coming from the field funnels through the structure. Erosion control fiber blanket was installed around the structure to minimize erosion from ground disturbed during installation.

The site is affected by backwater from the Hill River. The structure will need to be raised if monitoring is continued beyond 2007. This will help maintain head over the tail-water and reduce erosion. Modification of the structure may be necessary to “funnel” flow through the flume during high flows.

Figure 9. Stilling Well and Gauge on Bachand Surface H-Flume

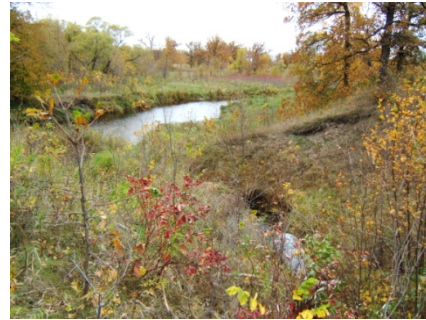
We needed to find a surface drained field nearby the Bachand field in order to make valid water quality and flow comparisons. This was actually the second site that was seriously considered as a surface drained site, but the first surface drained site in Red Lake County where samples were collected. The first site considered was south of Hwy 92 on a field owned by Keith Swenson - near a

University of Minnesota tile drainage research plot. When it was determined that the Swenson site would not work for accurate flow measurement without adverse affects to the farmer's crop, new sites were scouted for the project. The first choice was the Yaggie 1 site. The site is located on the north side of Section 1 of Poplar Township in Red Lake County, just east of the middle of the north end of the section. This monitoring site receives water from surface drainage on Kevin Yaggie and LeRoy Robert Carriere land. Initially, the outfall end of the culvert looked like a good place for a flume. Unfortunately, when water levels in the Lost River rose shortly after we started monitoring, we learned that the river water rises to the level of the culvert. This would make unobstructed flow measurement impossible during periods of high flow. The downstream end of the culvert is lower because of the drop structure on the upstream end. This site was abandoned in favor of Yaggie 2.

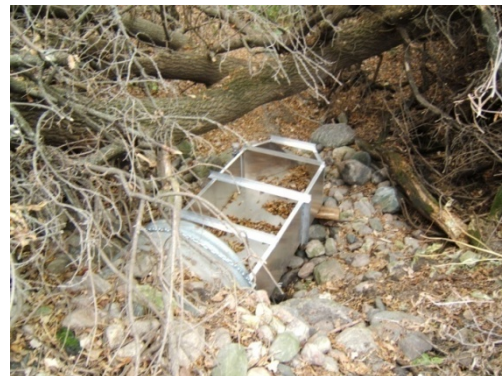
Yaggie 2

This site is located west of Yaggie 1 along a township road in Poplar River Township. There is more of a fall between the downstream end of this culvert and the Lost River than there is at the Yaggie 1 site. It would allow for unobstructed flow through the h-flume.

Therefore this site became the official site for measuring flow from a surface-drained field.

The h-flume used for flow measurement and this site is identical to the one at the Bachand Surface site. This site is located along north side of Section 1 of Poplar Township in Red Lake County, near the northwest corner of the section. The rear of the flume was sealed with Quikrete to make sure the water would flow out of the correct end of the flume.

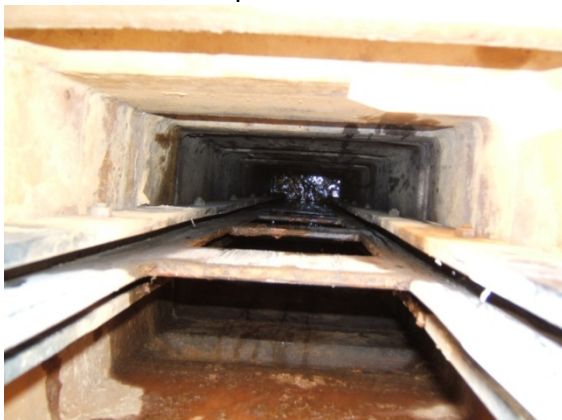
may have interfered with operation of the structures. The structures are also narrower and placed within the dike so it was difficult to collect a sample (even with a vertical Kemmerer sampling device) without disturbing the rust that lines the inner walls of the structure. Only one sample was collected in 2005 from a main-line tile outlet.

Figure 13. View down a Clearwater Rice Main Line Tile Water Control Structure

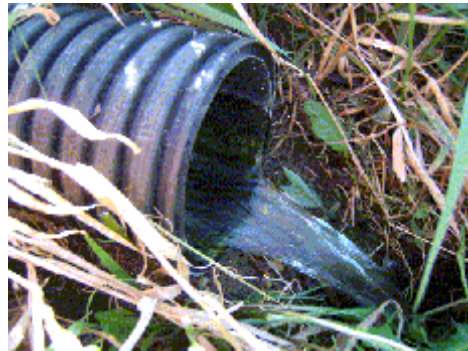
GT2 is located near County Road 55 on the north side of the field. It is northernmost tile outlet on this field. GT2 is not as easy to access as GT1 during wet periods. During wet periods, it is necessary to walk across a wet township road ditch and the water level in the receiving ditch may be high enough to cover the tile outlet. It was sampled more frequently because it runs longer into dry periods than GT1. So, GT1 will be sampled during wet periods (or whenever it is flowing) and GT2 will be sampled during dry periods (or whenever GT1 isn't flowing). These sites are located on the west side of Section 13 of Valley Township in Marshall County. They are on the east side of County Highway 54 and are along the field north of Arnold Stanley's home.

The tiling system on this field was installed in the year 2000. The depths range from 3.5 to 6 feet. The spacing is approximately 100 feet. Each of the 50 tile lines installed in the field is 2,500 feet long.

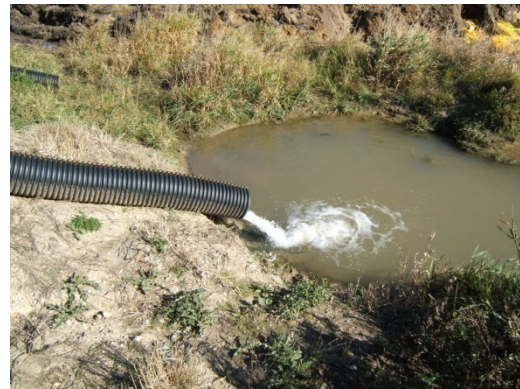
Stanley PT

This is a Stanley Farms' pumped tile outlet. Samples are collected at the end of the black corrugated outlet pipe while the pump is running. The pump can be triggered to run by opening the cover to the reservoir and raising the float. A new pump was installed in the fall of 2005. Samples are collected from the pump that is closest to the road (first pump installed). This site is located where Sections 12 and 13 of Marshall County and Sections 7 and 18 of Beltrami County meet. The pumps are along the north side of Marshall County Highway 55/Beltrami County Highway 44 (gravel road) at the section line.

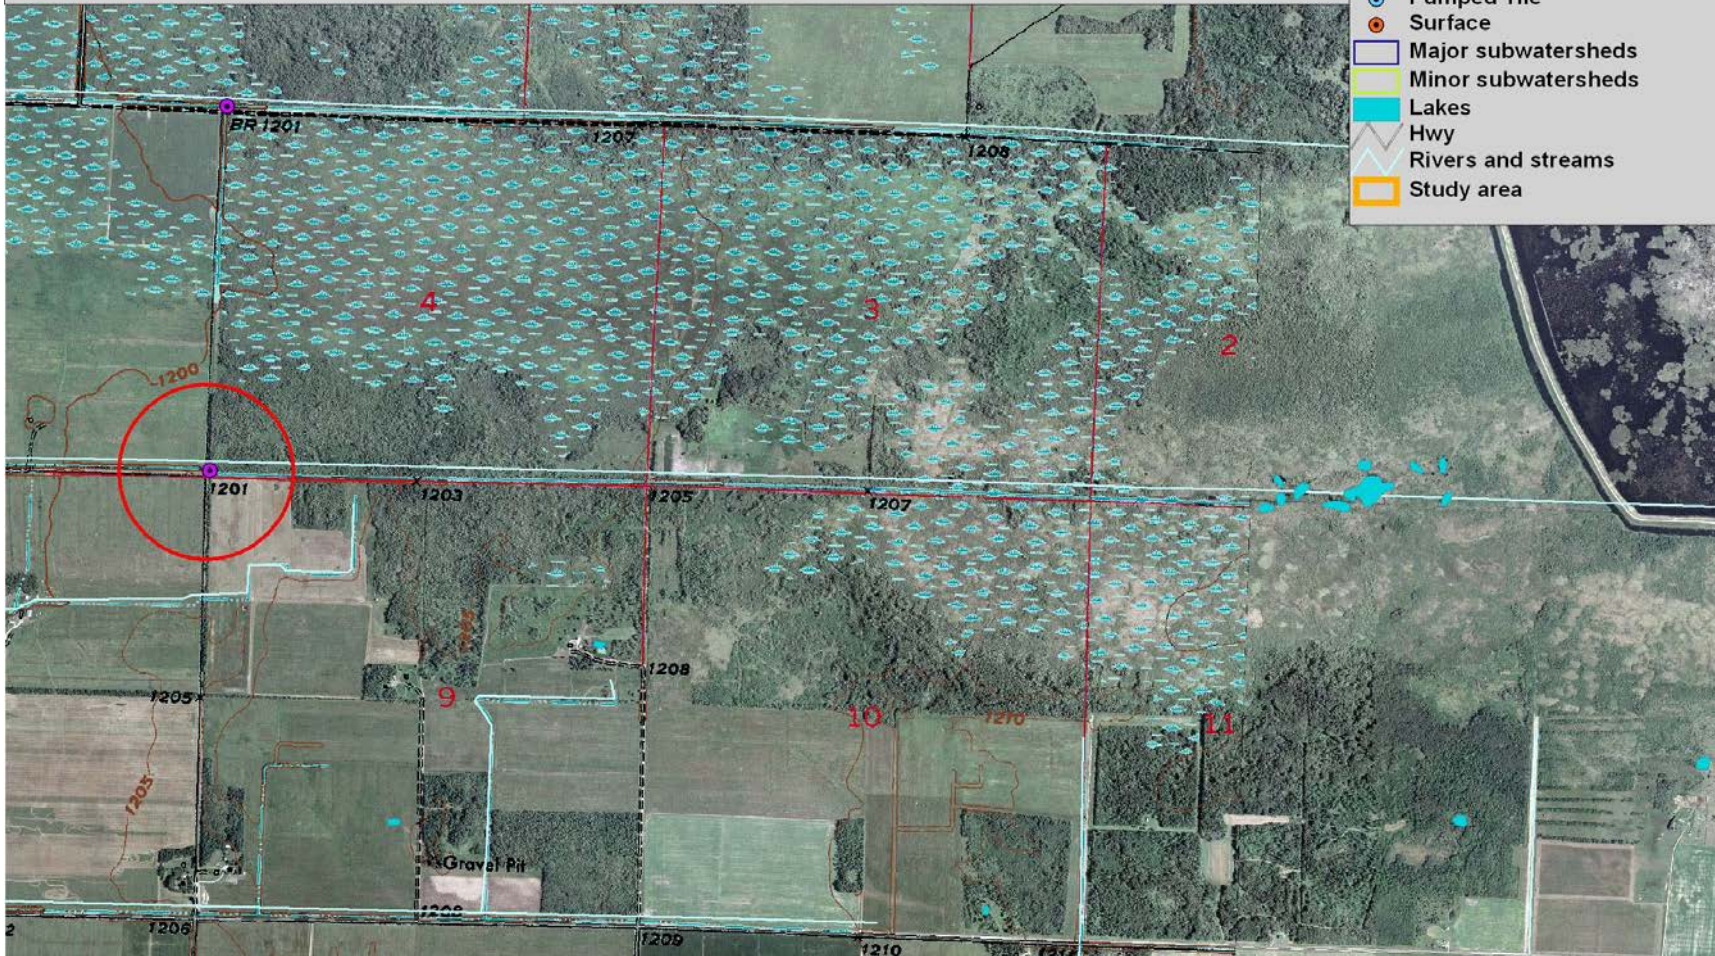
- Possible monitoring sites
- Outlets
 - Gravity Tile
 - Natural
 - Pumped Tile
 - Surface
- Major subwatersheds
- Minor subwatersheds
- Lakes
- Hwy
- Rivers and streams
- Study area

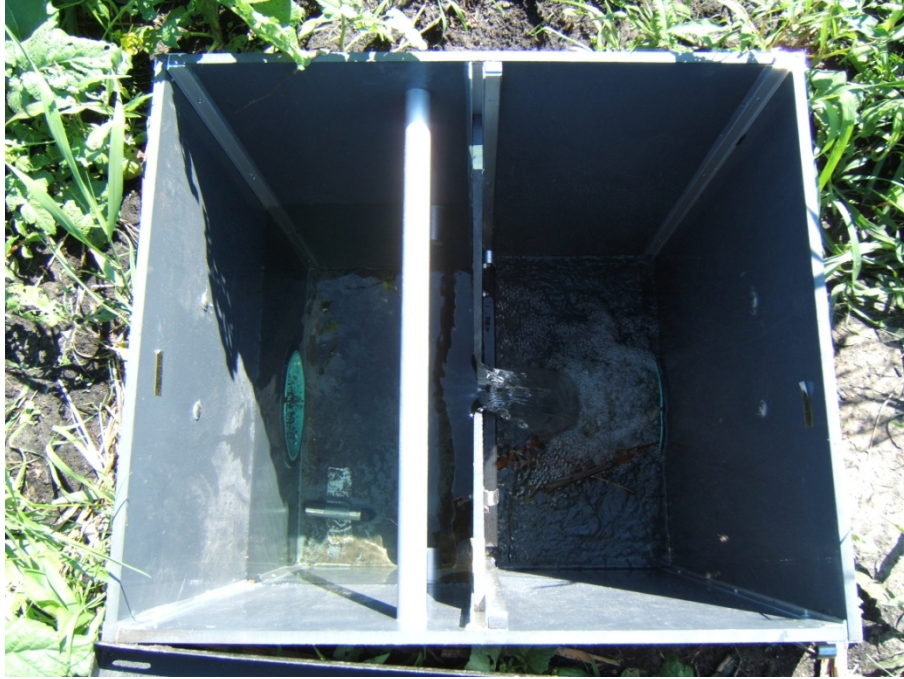
Figure 14. Bachand Tile Drainage Water Control Structure

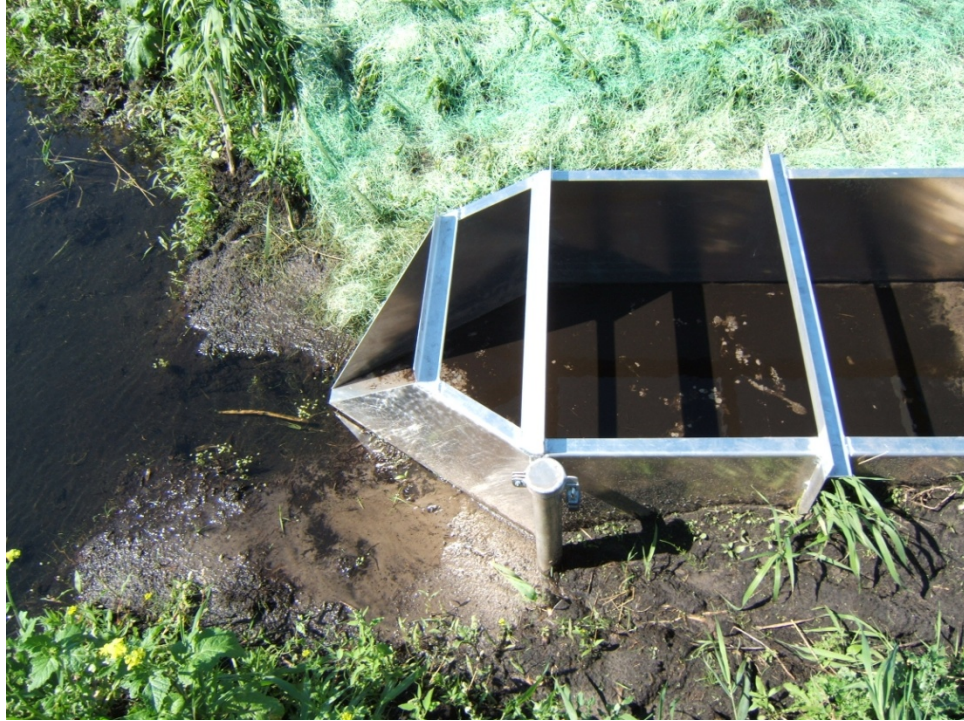
Figure 16. H-Flume for Surface Flow Measurement at the Bachand Site

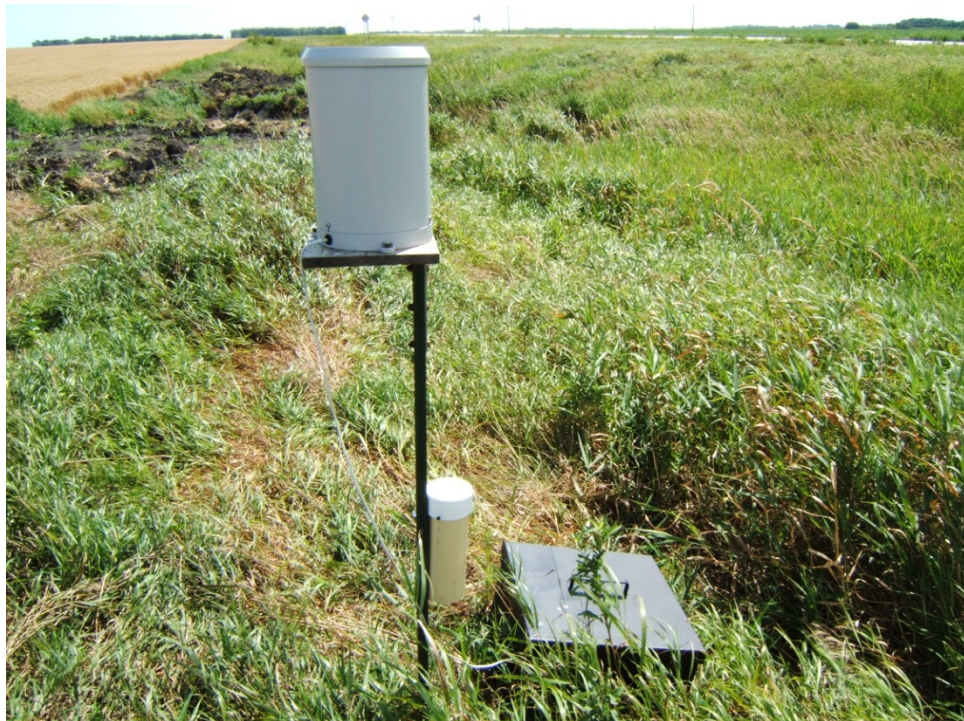
Figure 17. Rainfall and Barometric Pressure Monitoring Equipment at the Bachand Site

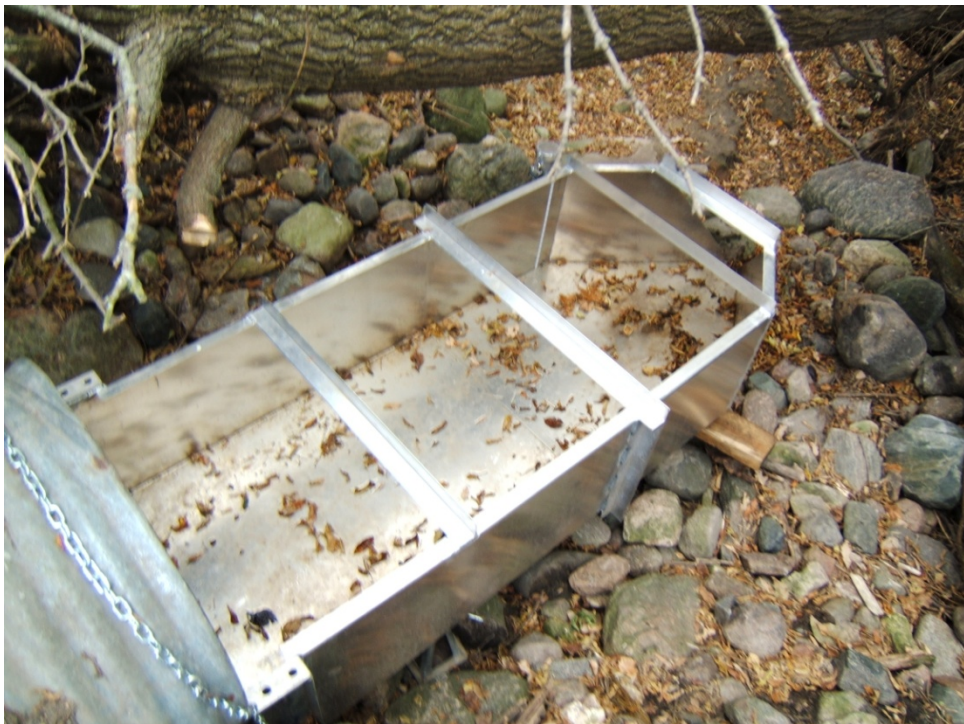
Figure 19. H-Flume on Downstream End of Yaggie 2 Culvert
